Leak Detection – Heating system

Project Outline

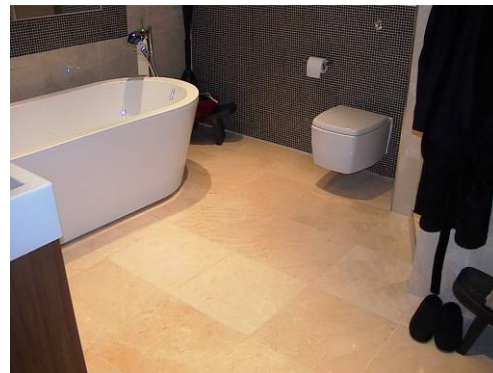
Image 1. Visual of Bathroom

The main leak was located within the bathroom and only resulted in the lifting of 2m² of flooring during the repair. This meant the apartment could be re-leased within 5 days.

Image 1 shows the visual image of leak.

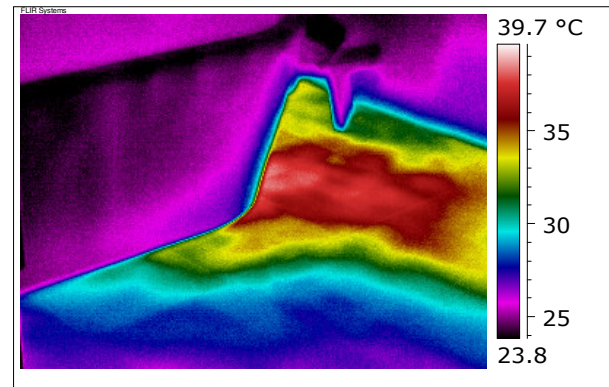
Image 2. Thermographic image of Bathroom

Image 2 shows the thermal image with the leak in red and yellow colours.

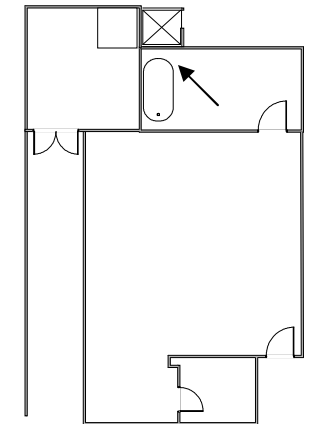
Fig 1. Building Plan

Fig. 1 shows a building plan with the location of the images shown.
